Revegetation at Crater Lake National Park:  
A Survey of Historic and Active “Orphaned” Sites.

Susie Roe Andersen  
Biological Science Technician – Botany  
Crater Lake National Park  
September 26, 2008

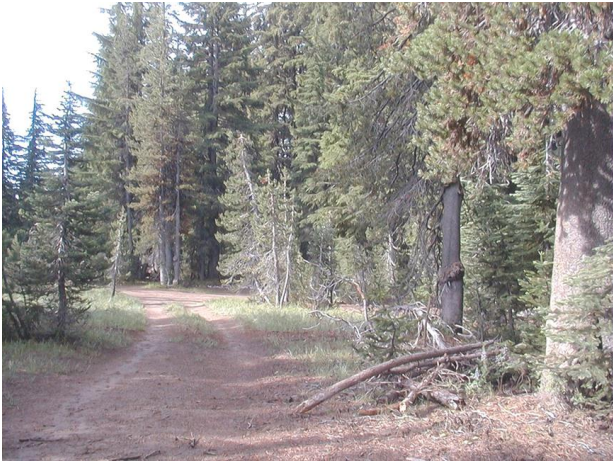
**Restoration Success/Failure:** This project had approximately 30% success. The Social Road (Fig.2) and revegetated picnic table area (Fig.3) are still clearly visible with mostly barren soil and sparse vegetation compared to the meadow it runs through. The jute erosion matting is wadded up on the sides caught by downed logs, and the green “photodegradeable” plastic matting is clearly visible and does not appear to be degrading after 10 years (Fig. 6). Only two of the transplanted *Tsuga mertensiana* seedlings survive along with sparse grasses, sedges and forbs (Fig. 4,5)

Fig. 2 – Vidae falls social road before restoration. Photo courtesy of Cheri Killam-Bomhard, Crater Lake NP.

The jute and plastic erosion matting should be removed from the Social Road, picnic table site and restroom area where possible (left intact if removal would jeopardize the plants). Since the sites were not maintained properly after the original restoration, most of the areas need a full restoration once again. This will include removing old matting, seeding, transplanting and placing new matting, and regular watering.

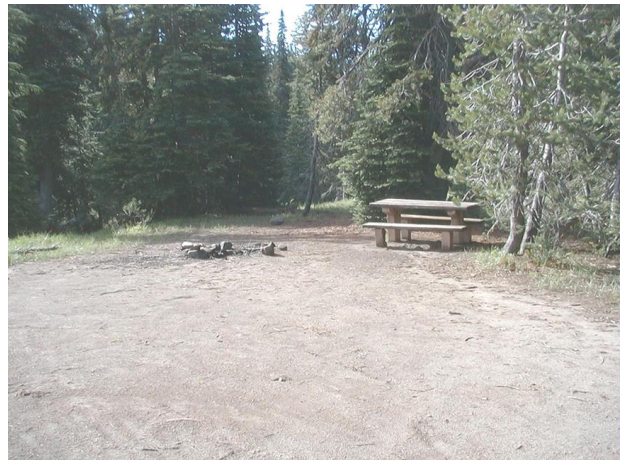
Fig. 3 - Vidae falls picnic table area before restoration. Photo courtesy of Cheri Killam-Bomhard.

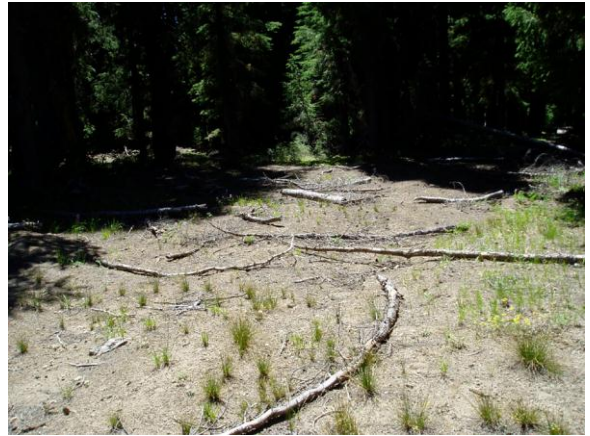
Fig. 5 – Vidae falls social road and picnic table area after restoration.

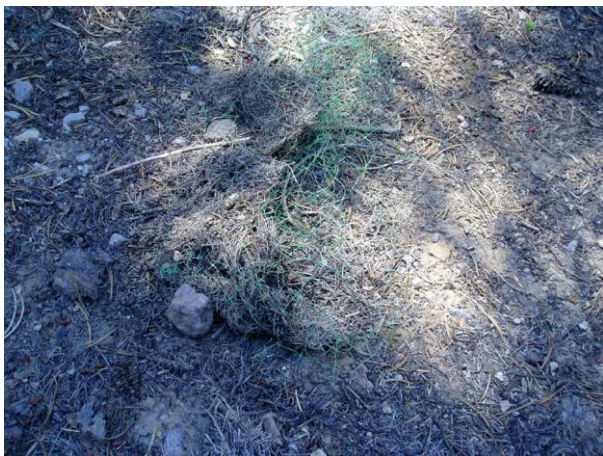
The revegetation around the restrooms had approximately 20% success (Fig.7). This site also has clearly visible erosion matting wadded up in various places as well as the plastic “biodegradeable” matting. The area in front and behind the restrooms and along the culvert is especially barren. A survey of the restroom area found the following species:

Fig. 6 – Vidae Falls “photodegradable” erosion matting used on social road and restroom area.

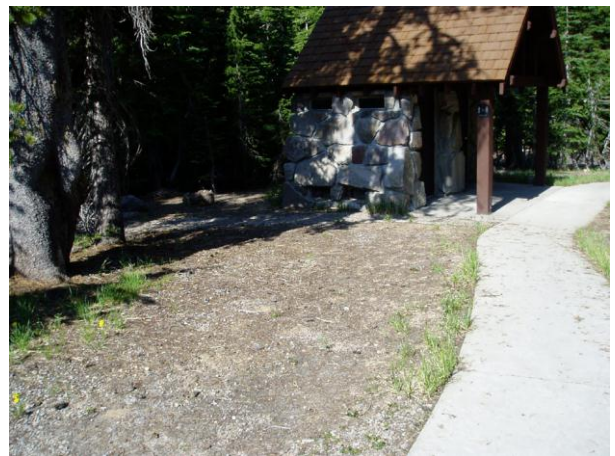
Fig. 7 – Vidae Falls restroom revegetation.

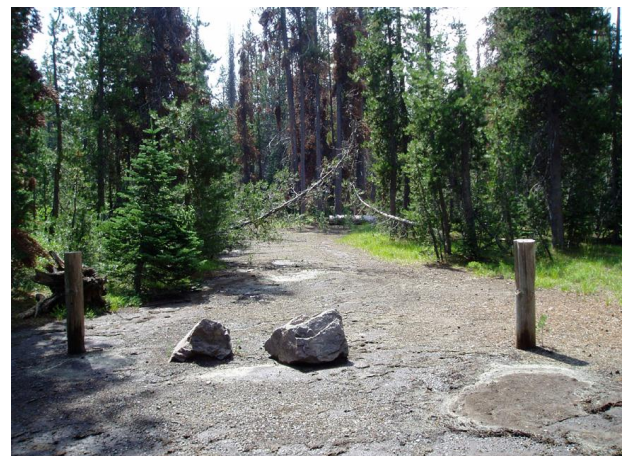
Fig. 14 – Lost Creek campground reveg site #6 with erosion gully draining into Lost Creek in foreground

Site #6 is in greatest need of restoration due to the erosional run off into Lost Creek and the lack of vegetation throughout the site. Sites #7 and 8 should also be restored.

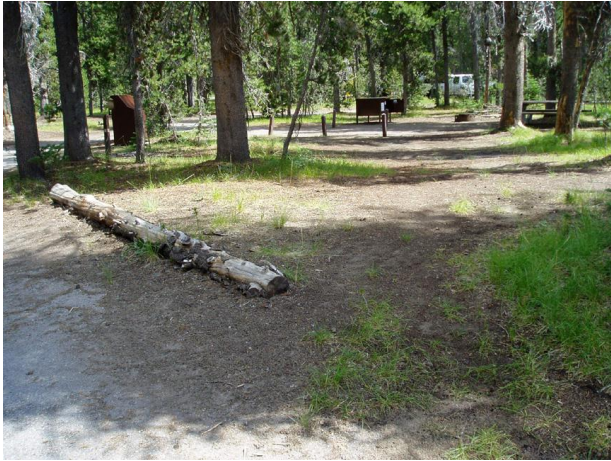
Fig. 15 – Site #8 still in need of revegetation.

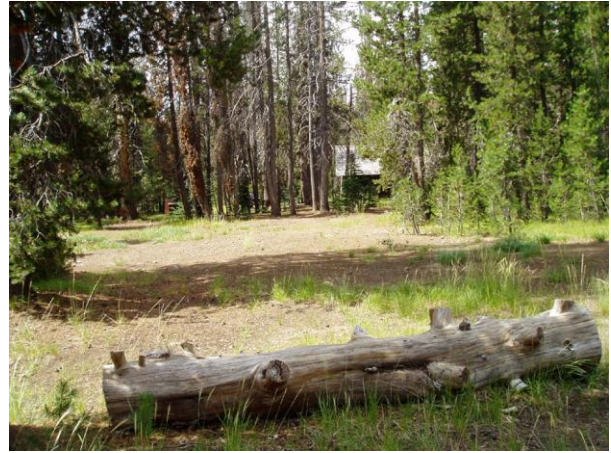
Fig. 16 – Lost Creek campground leach field. View toward restrooms.

Another high priority site is the leach field that was installed in July 2004 but was never restored (Fig. 16,17). This area is in plain view of visitors as they enter into the campground. The site is barren except for a few *Pinus contorta* and *Abies x shastensis* volunteers.

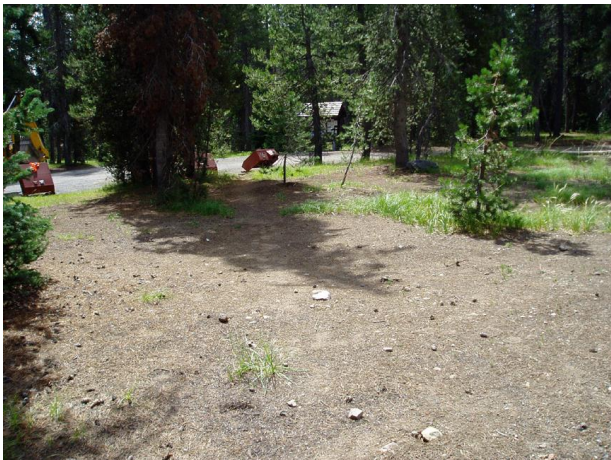
Fig. 17 – Lost Creek campground leach field. View towards information kiosk.

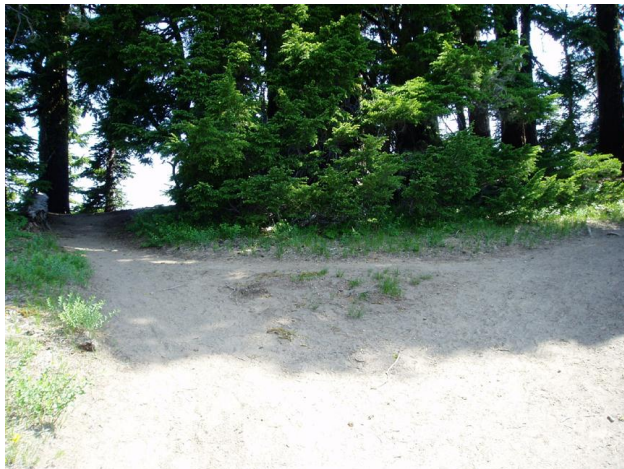
**Current Conditions:** The area has a network of social trails. The first social trail begins about 20 feet from the trailhead and goes to the left around a group of mountain hemlock (Fig. 25). The official trail is excessively wide in many places and has sections with significant erosion over exposed tree roots. The remains of small social trails go through the center of the meadow (Fig. 24). Another eroded social trail leads to the right off of the main trail and is so wide it looks like an official trail (Fig. 26). A network of social trails winds in and out of the forested rim area (Fig. 19), down into the caldera (Fig. 20), towards the west to Applegate Peak (Fig. 22) and the east to Dutton Ridge (Fig. 23). Wide areas of trampling have denuded the vegetation to bare soil (Fig. 21).

Fig. 21 – Sun Notch vegetation trampling as social trails widen.

**Recommendations:** A new plan for flow of foot traffic at Sun Notch is vital because visitors will continue to look for the shortest distance to the rim as possible. Social trails through the meadow and at the rim should be revegetated with on-site native seeds, with the exception of Crater Lake current *Ribes erythrocarpum* which is a host for the whitebark pine blister rust fungus (see Rim Village cafeteria/whitebark pine restoration). Log barriers should also be placed to direct traffic flow. Interpretive signage should be placed to educate visitors about the delicate sub-alpine meadow ecosystem and encourage responsible hiking. During spring melt-out the trail should be marked so that social trails don’t develop when visitors cannot locate the main trail. Species recommended for seeding are as follows:

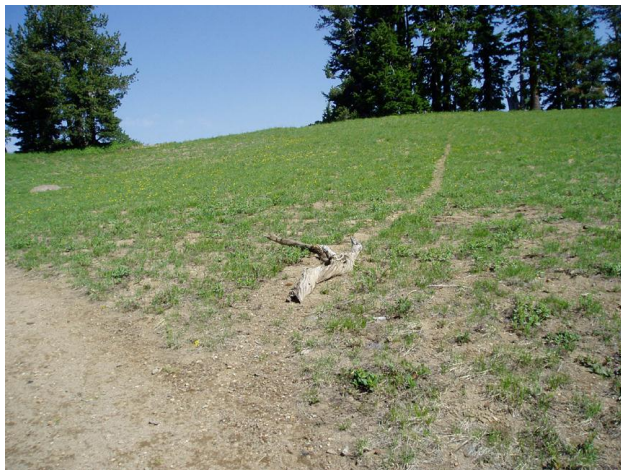
**Restoration Successes/Failures:** The lower wooded site has 100% success. There is no evidence of this social trail. The upper meadow site with the small social trail was 70% successful. The small social trail is still evident from the lower meadow where vegetation on the trail is sparse (Fig. 24). About 1/3 of the way up the social trail disappears and is obscured by the following species:

Fig. 24 – Sun Notch small social trail through meadow 25 years after revegetation.

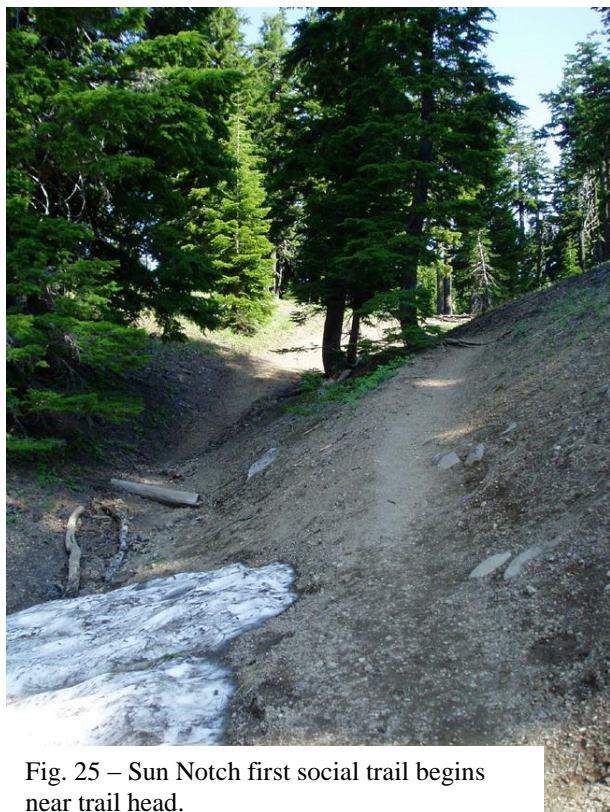
Fig. 25 – Sun Notch first social trail begins near trail head.

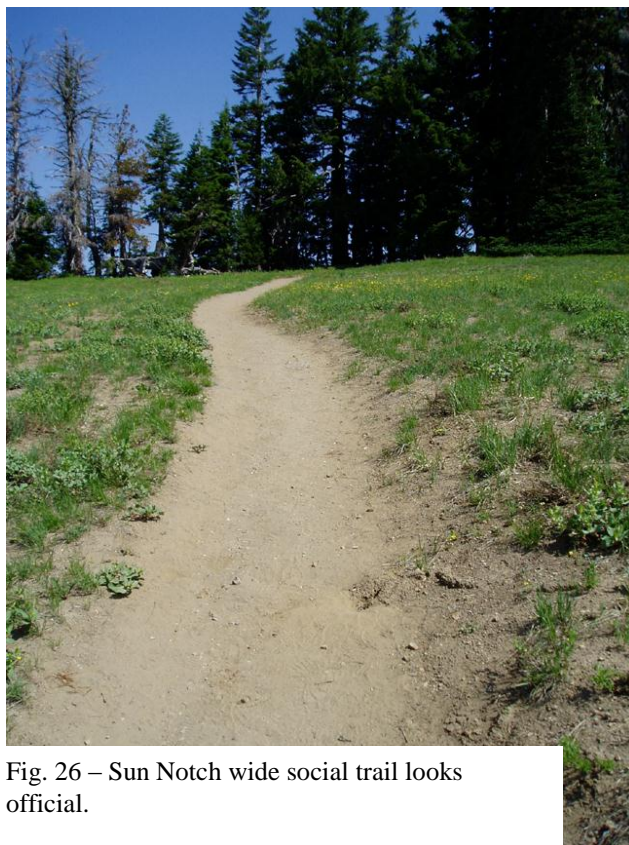
Fig. 26 – Sun Notch wide social trail looks official.

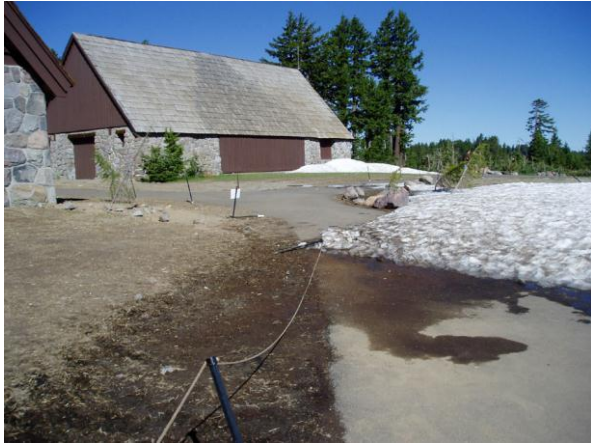
Fig. 27 – Rim Village revegetation trampling during snowmelt.

1. A permanent fencing/barrier system must be installed in this landscape. The foot-traffic patterns were not designed with human ecology in mind, so visitors who want the most direct route to the rim to view the lake cut directly through the new landscape. Without a physical barrier, visitors will continue to take shortcuts and damage the plantings. Even with the rebar installed to strengthen the plastic poles, they are subject to pulling out by visitors.

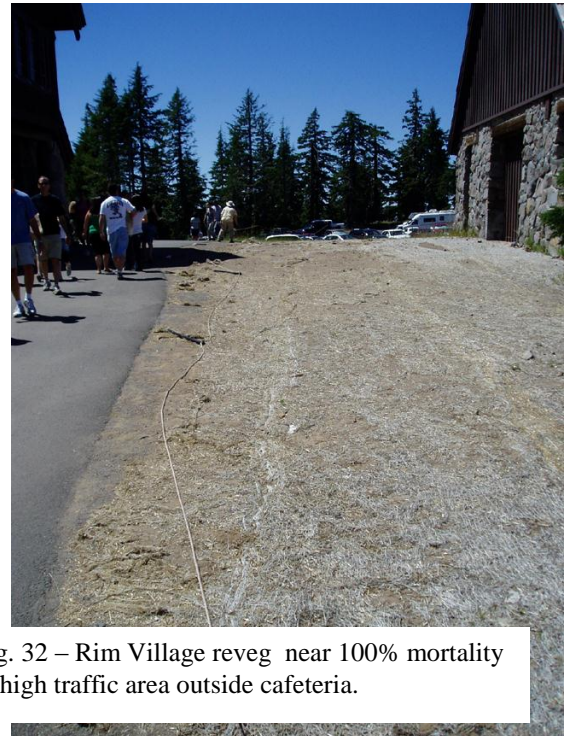
Fig. 32 – Rim Village reveg near 100% mortality in high traffic area outside cafeteria.

4. Soils need augmentation to increase fertility in some areas, especially around the entrance to the cafeteria building.
5. The area near the cafeteria entrance had near 100% mortality and needs to be revegetated again after soil augmentation.

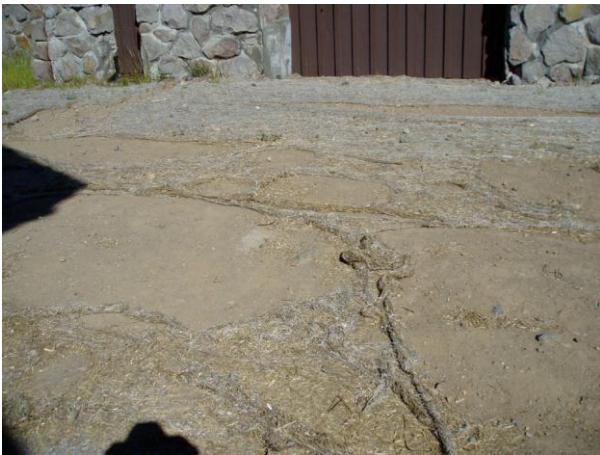
Fig.35 – Rim Village reveg near 100% mortality on west side of cafeteria.

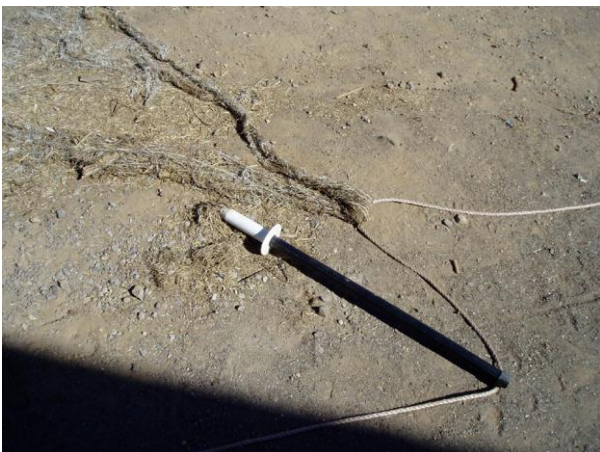
Fig. 36 – Rim Village reveg pole sockets unsuccessful in hard packed soil.

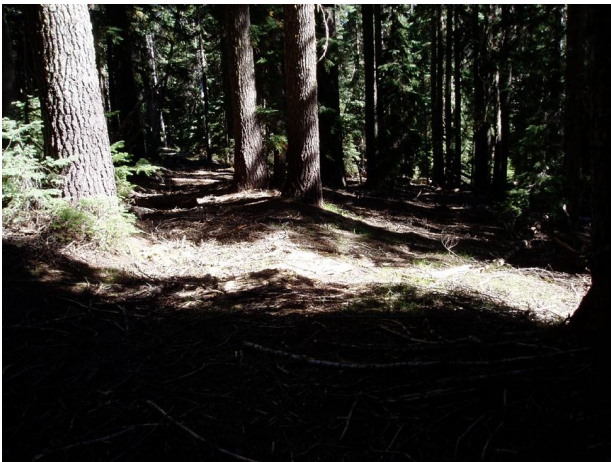
Fig. 40 – Bert Springs trail diversion from old road bed is difficult to see.

**Recommendations:** Much of the habitat in this area is unsuitable for *C. mazama*. Concentrating efforts to protect habitat at other locations makes better sense. If continued restoration is desired in this area it must be cleared of the downed logs, branches and other debris that is now covering *C. mazama* habitat. Since this closed canopy area is not ideal habitat, the highest priority for this site is to make sure that hikers take the trail re-route that leads them south of the *C. mazama* population on the old road/trail. Trail signage and trail work to make the diversion clear is vital.

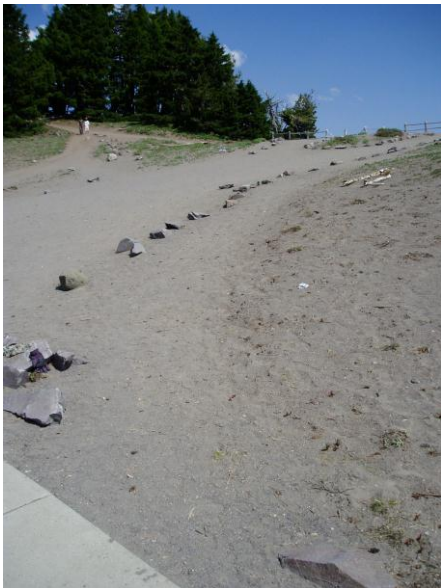
Fig. 64 – Wide central trail, social trails and trampled vegetation with old rock work

Recommendations: This is one of the most critical revegetation sites in the park. It is the first overlook of Crater Lake that visitors encounter when entering the park from the north. It is also the conduit for foot traffic up Llao rock, potentially trampling the Crater Lake Moonwort (*B. pumicola*), a rare plant that is a Federally listed Species of Concern and State of Oregon listed as Threatened.

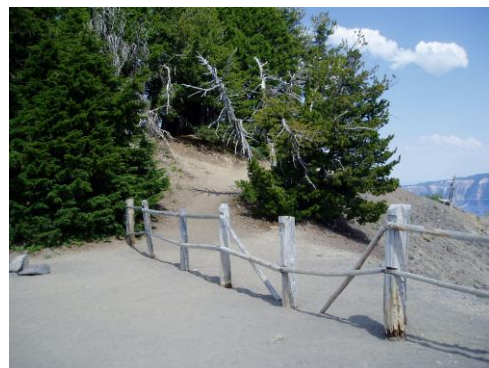
Fig. 66 – Inadequate fencing at rim overlook.

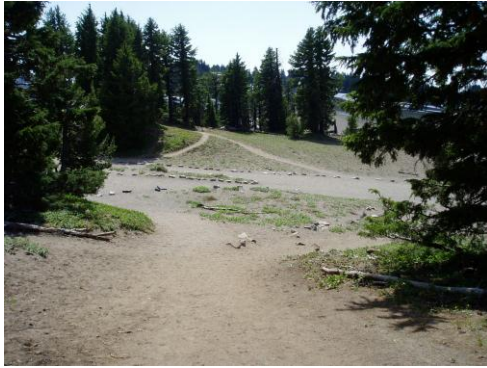
Fig. 67 – Social trails weave in and out of forested areas from central “trail”.

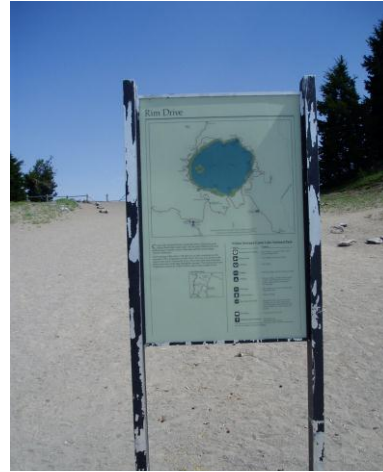
Fig. 68 – Inadequate interpretive signage looks as sad as the denuded site.

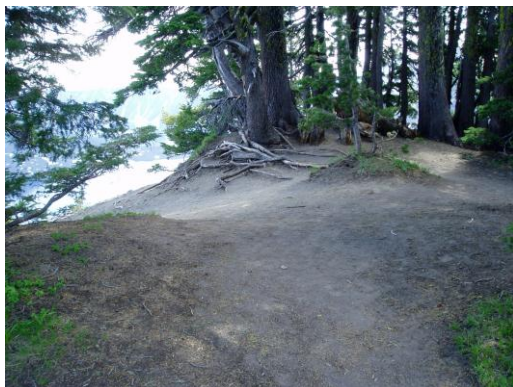
Fig. 71 – Social trail damage to vegetation.

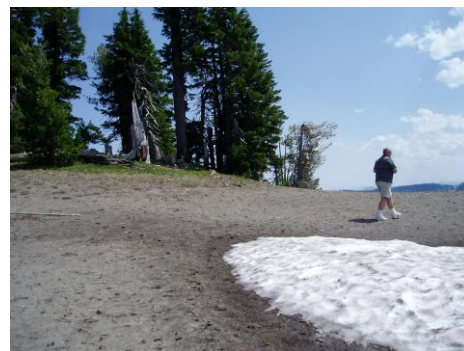
Fig. 72 – Visitors walk indiscriminately from parking area to rim.

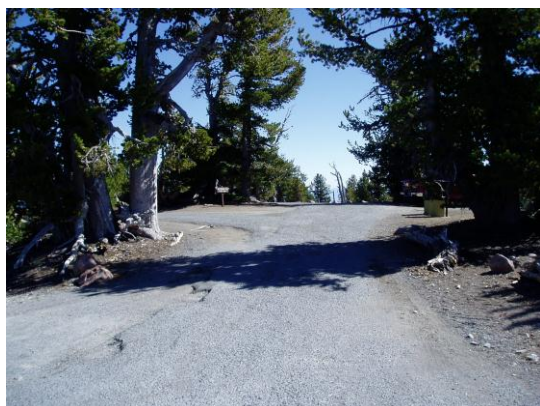
Fig. 77 – Entrance to Whitebark Pine Picnic Area with broken pavement and off road impacts.

Recommendations: This site needs a complete overhaul to improve aesthetics, parking and traffic congestion. More picnic tables are needed to serve the number of visitors wanting to use the site. New paving and designated paved parking spaces for each site would eliminate the chaotic parking and trampling of vegetation (as was done at Vidae Falls Picnic Area). Revegetation of areas where cars currently park, and in between and around picnic sites is needed. This area could also use revegetation of whitebark pine since seedlings have been trampled or driven over.

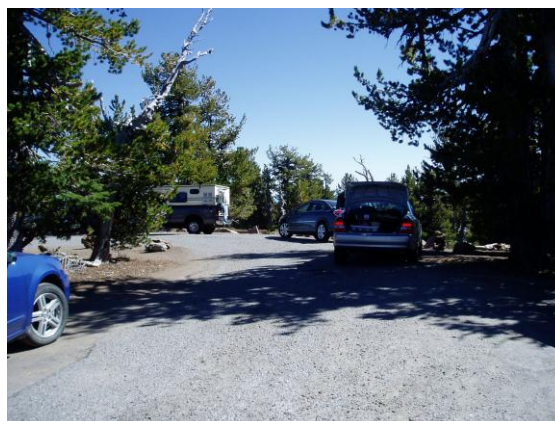
Fig. 78 – Traffic congestion and off road parking.
